Process Report

Argos Free-Trade Zone

Background: The installation of the Seal Plus seal system by Motofrenos was installed at the annual maintenance of kiln 4 in the year 2015.

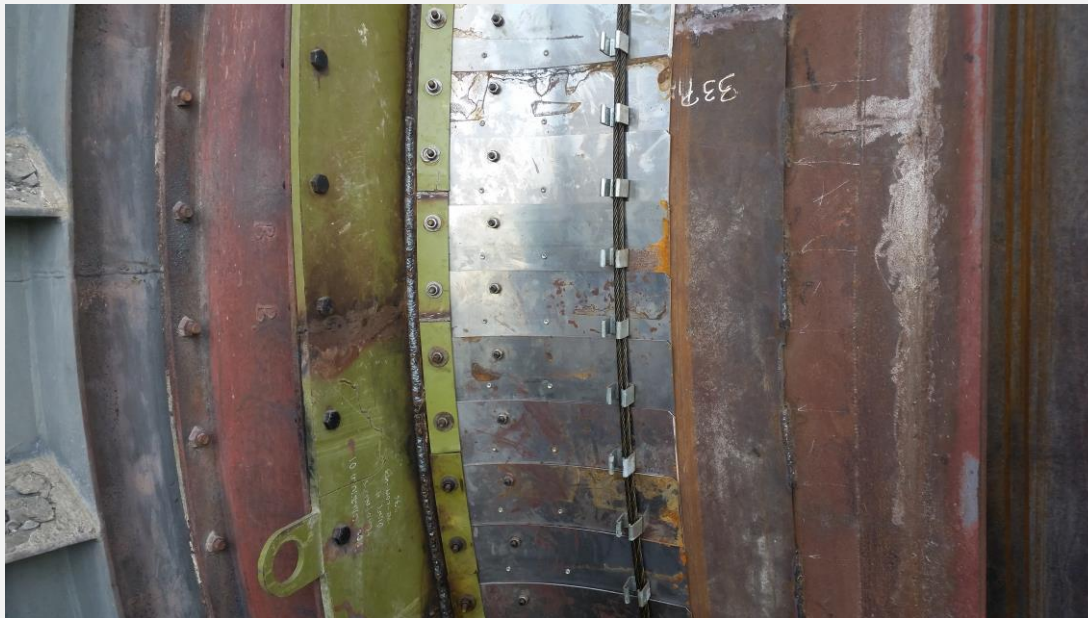
During the kiln's performance assessment we concluded that given the volume control determined for kiln 4, there is false air intake in the process;

- Increase in energy consumption
- Decreased efficiency of the ID fan
- Calcining process out of control
- Crystal formation due to changes in the cooling area

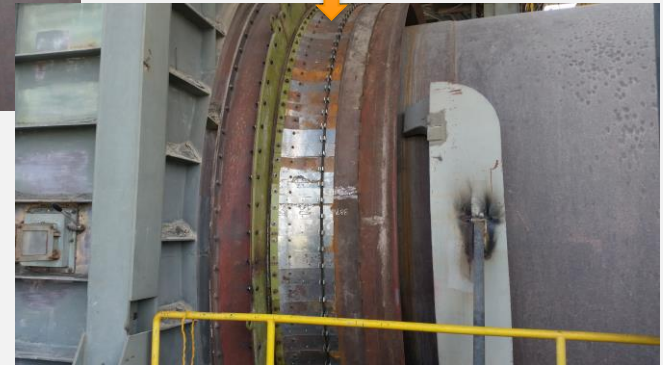
Increase in energy consumption:

The false air intake is calculated based on the percentage of oxygen in the system. At the beginning of the kiln's outage, the amount was 9.5% of O₂ and after stabilizing the equipment after the installation, the amount was 4.5%, these were measured between the inlet and the discharge of the kiln.

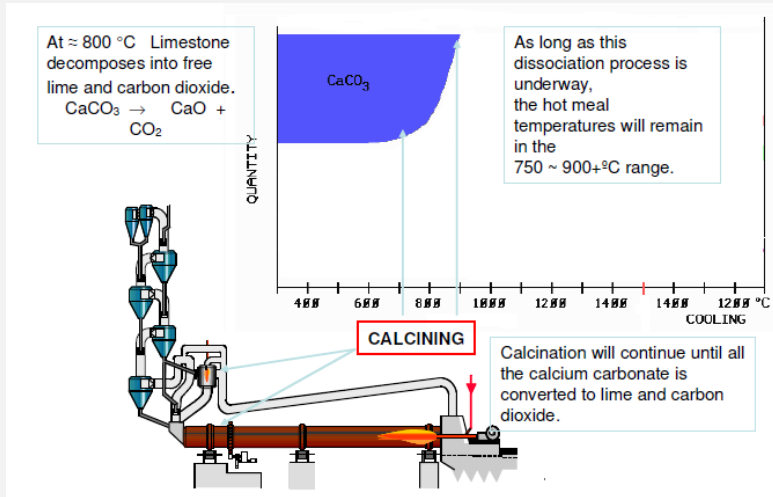
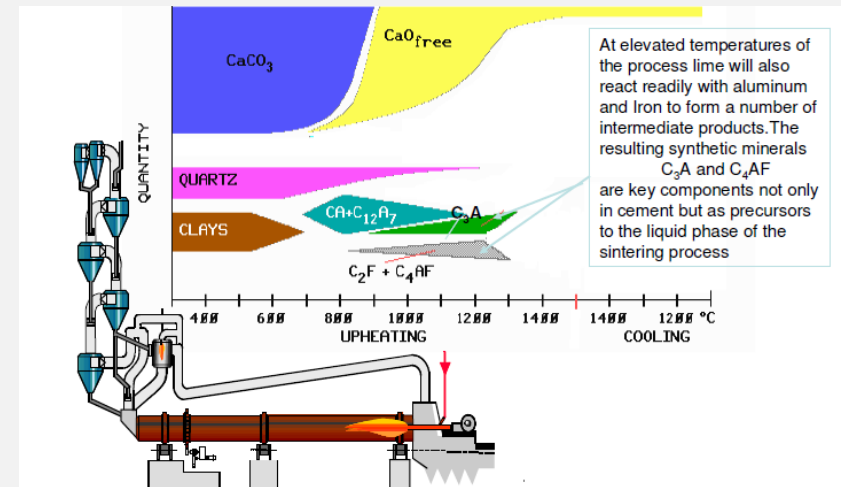
Calcining process out of control:

The unstable dynamics of air flow entering through the discharge seal modified the performance of the flame, causing negative issues in the process and wear of the refractory at the kiln's inlet and discharge.
