# NewSeal in Horizontal Ball Mill

## A practical and efficient solution for the cement and mining industry

## Mill seal, a new challenge for our project scope

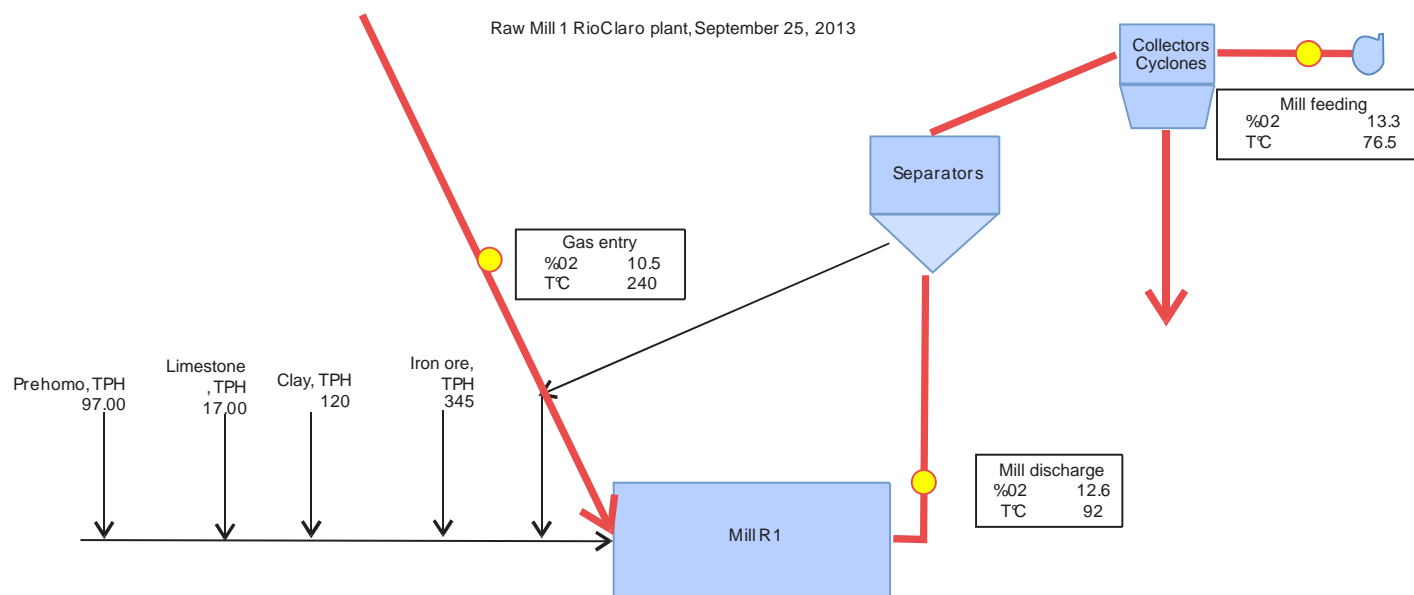
## Before the mounting

Attached is an oxygen measurement at the entrance and exit of raw mill 1 before the mill seal mounting and after that assembly.

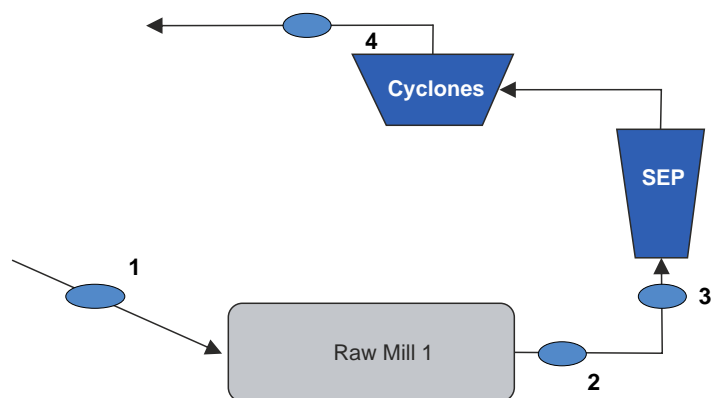
## After the seal mounting

Oxygen profile Raw 1	%O <sub>2</sub>
1	Mill feeding	11.35
2	Mill discharge (dead step)	11.68
3	Mill discharge (under the separator)	*12.1
4	Cyclone outlet duct	12.81

Notice how the false air drops approximately 20% with the seal

\*This value may be affected by the size of the sampling point that is great, allowing air inlet while the measurement is performed, therefore the value may be less.

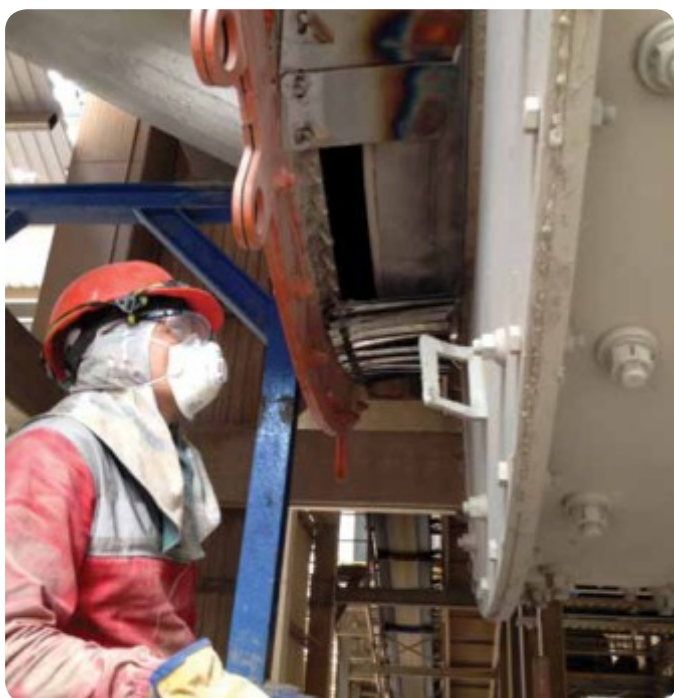
This image details the continuous inspection we make to each of the 320 leaflets that make up the entire seal by verifying their status. While inspecting we take into account the mill speed and the temperature variation in the process at the moment of loading the mill and its radial deformity.

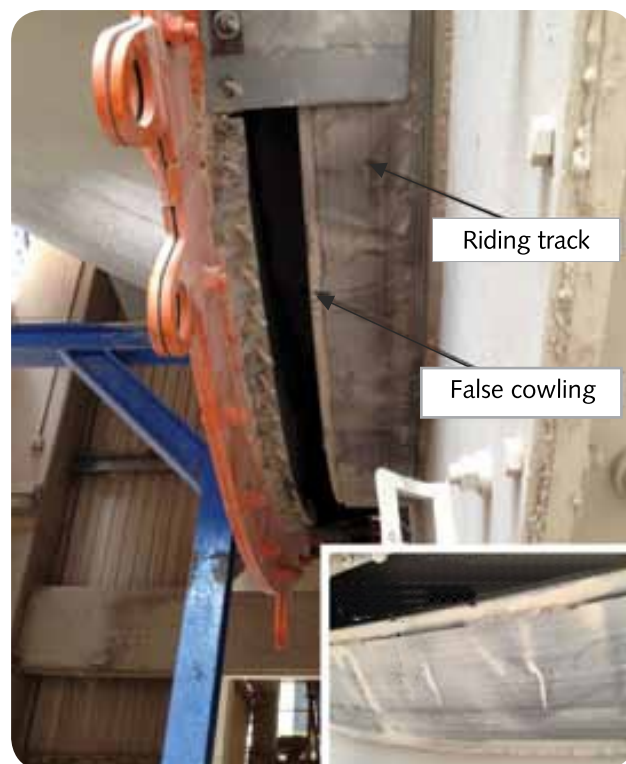
The following image shows another test passed, the state of the riding track. This item is in constant contact with the leaflet, the quality and formulation of the steel met the projected expectations, the wearing out after 4 months of constant operation was 3% considering that the riding track has a thickness of 10 millimeters.
